**Mould Survey
Northern Beaches Police Station
November 2022**

QBuild – Mackay District Office

Mechanical Services Engineering Heating, Ventilation and Air-Conditioning System

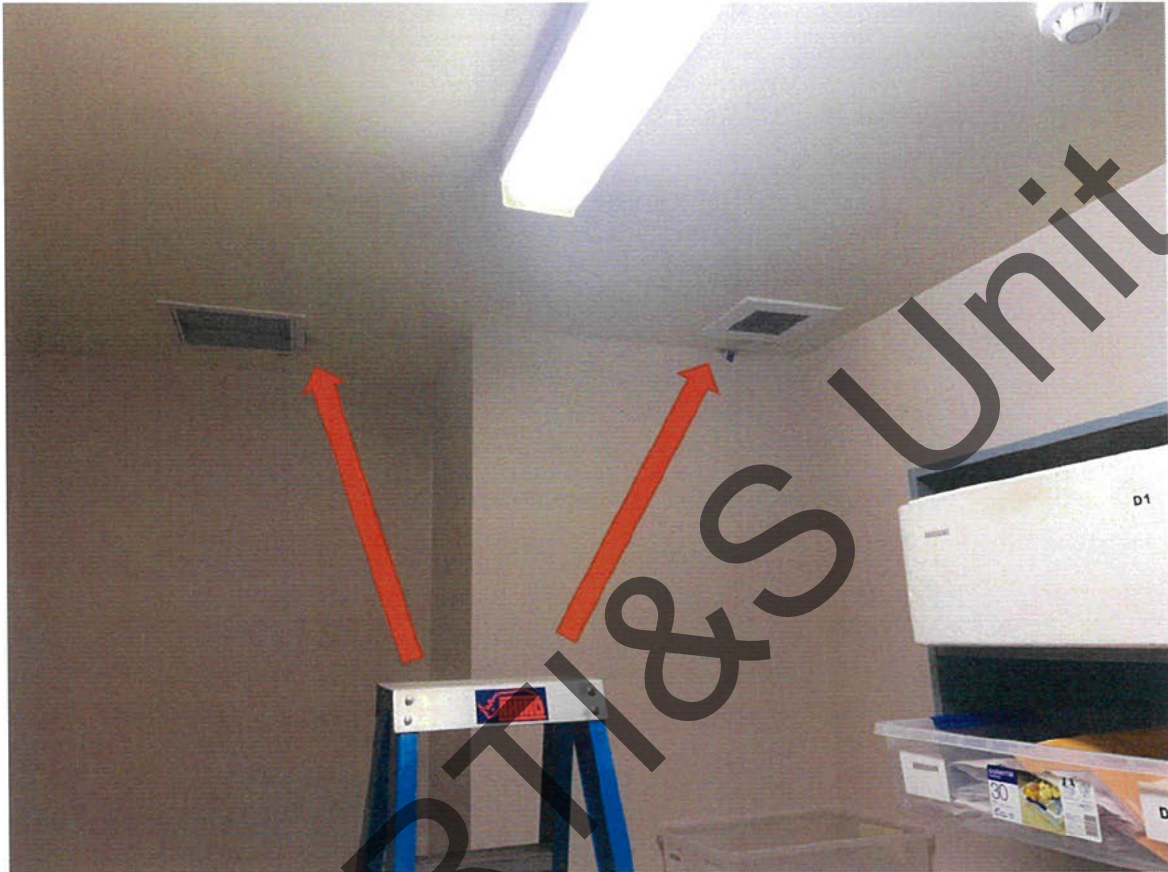
- a. Localised active mould growth was noted to vent surrounds in the Drug room as detailed in Section 5.1 of this report.
- b. Mould affected areas around the vents **did not** return an excessive MC% (all <12MC% when tested). The wall area was dry at the time of survey, and the mechanism of mould growth in the area appears to be water condensate leakage around the vents.

- d. Humidity levels in the Drug room and Property room **were outside of guidance ranges** (>65%RH). The operation of the air conditioning unit in the drug room (which is a relatively small volumetric space) at low temperatures when excess humidity is present is likely to result in periods of condensate accumulation on certain surfaces with low surface temperatures (e.g. metal vent frames).

Photo 1 – Mould affected sections of ceiling adjacent vents

- R1 There is **no recommendation** to either cease or alter current occupancy of surveyed building areas based on the findings of the current survey program.
- R2 Mould affected ceiling sections adjacent vents in the Drug room should be prioritized for cleaning.
- R3 Control of humidity levels within the drug room to <65% should be maintained to prevent the development of condensation of room surfaces as are result of dew point conditions. Use of a dehumidifier, or adjusting the Drug room air-conditioning temperature to a higher setting (e.g. 25-26°C) will likely mitigate the formation of condensate within the room.

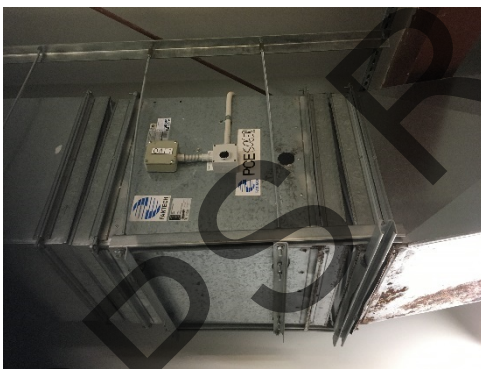
OAF-1 (duct corrosion on right)

- There is some surface corrosion on existing ductwork which needs to be removed and the duct coated.
- The existing roof space ventilation louvres is not considered as a possible cause of the condensation issues. It can help to ventilate the roof space with added whirly birds.

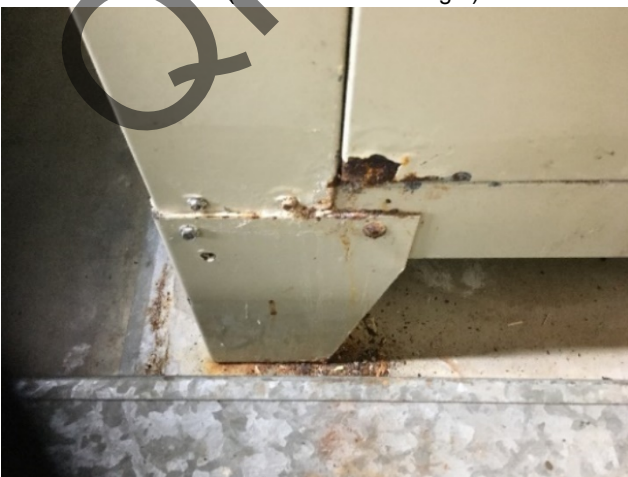
AC plant corrosion

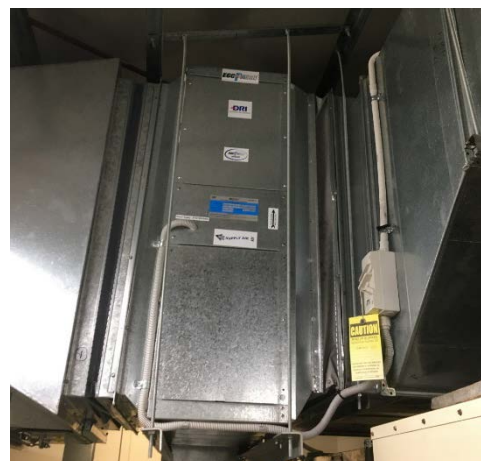
HRW with isolator tagged-out

- The Heat Recovery Wheel (HRW) was replaced in 2019 but has been tagged out. This needs to be investigated and the unit rectified and returned to service. The HRW can be deleted in future as the relatively low energy savings does not appear to justify the capital and operating cost of the unit. After sales service is also lacking locally.

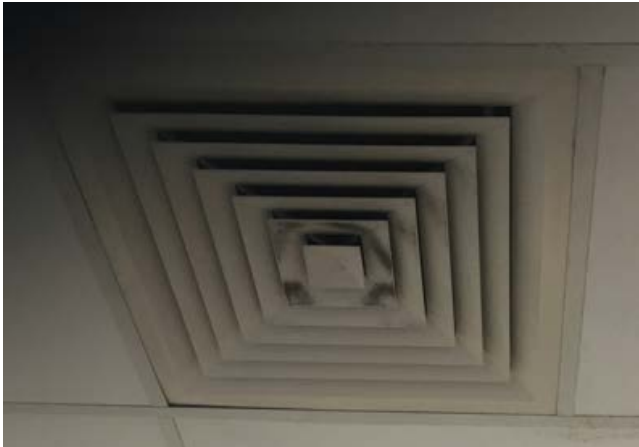
Typical ceiling diffuser with smudging

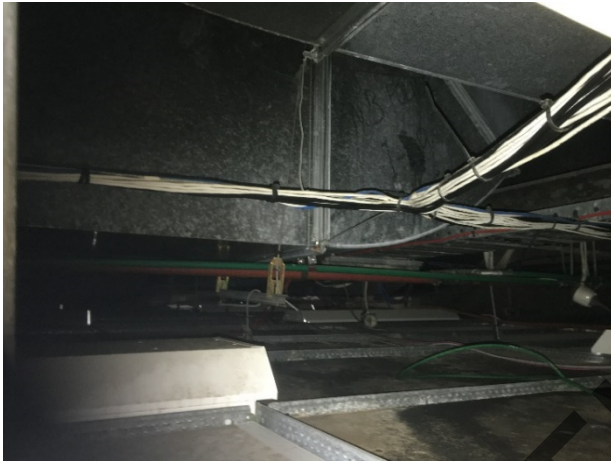
Ductwork	Some ceiling tiles were removed and the ductwork and cushion boxes were inspected. Some surface corrosion was observed. The ductwork are internally insulated but the condition of the insulation cannot be ascertained.	Condensation on the ductwork was reported in the past leading to damaged ceilings. It was mainly observed in the main duct of unit AC-2. This is possibly due to a deterioration of the ductwork internal insulation.
AC-1 zone	The SA layout is acceptable. There is one RAG above Passage 3 and one wall temperature sensor located in Passage 6 outside the Station OIC.	It is preferred to locate the RAG in the actual zone. It can be shifted to the Sergeant's Day Room ceiling. The wall sensor is not in the ideal location and can be relocated to a more open area. Another sensor can also be installed for better control using averaging or high select.
AC-2 zone	The SA layout is acceptable. There is one central RAG with temperature sensor located inside.	Location of RAG is acceptable. It is preferred to locate temperature sensor in the conditioned space for accurate space temperature monitoring but may not be critical in this application as the occupancy is variable due to staff movements.

Typical ceiling space

- Condensation has been observed on the main supply ductwork which has internal insulation but it is difficult to determine the cause without dismantling the entire duct for inspection. The duct will need to be re-insulated externally.

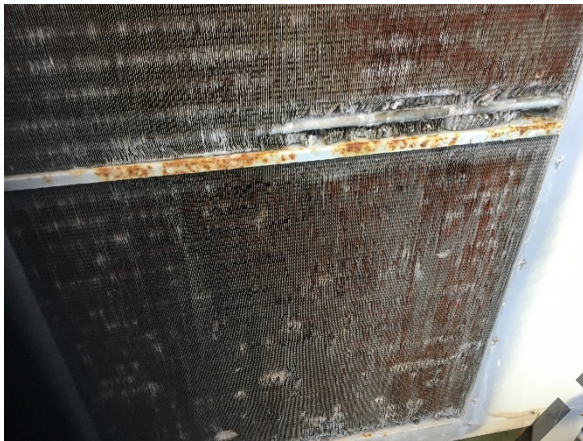
AC-2 condenser corrosion

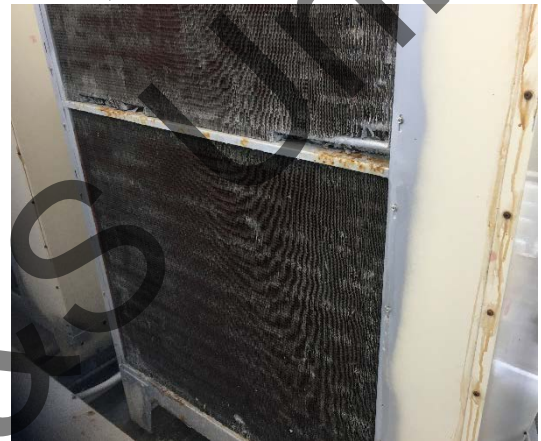
AC-1 condenser corrosion

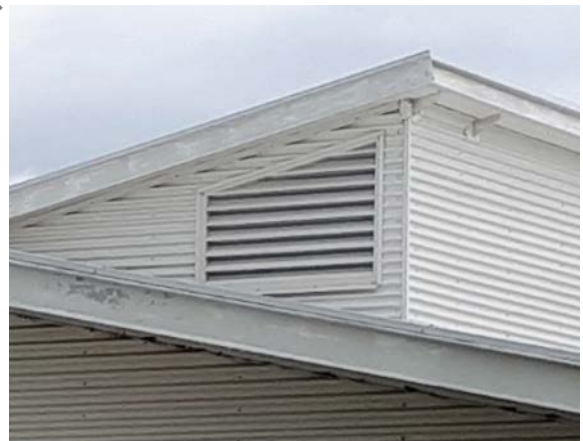
OA intake	Some marks on the wall is observed below the OA wall intake blanking plate. Some leakage many have occurred. The OA louvre as observed from outside has wide gaps (see Fig. 6).	Rain may have leaked into the plant room through the OA intake louvre. This can be observed and the louvre changed if necessary.

OA intake louvre to OAF-1

- The proportion of OA compared to total SA is not high and the DX units are expected to have the capacity to condition the RA and OA mix.
- The existing OA intake louvre may let in rain during storms and can be replaced with a rain louvre.
