MOULD ANALYTICAL REPORT

Property: WO17802457
Logan Central Police Headquarters

Mould Investigation

Logan Central Police Station

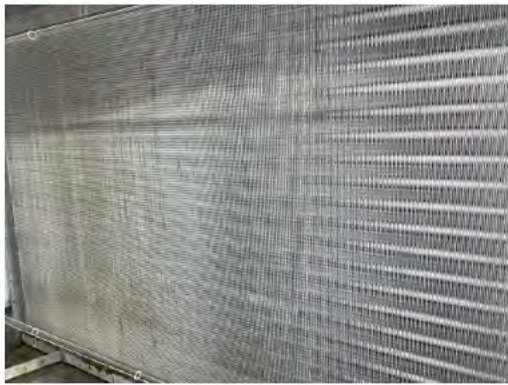
**Image 3 – AHU 1.A Cooling Coils
Air Off Before**

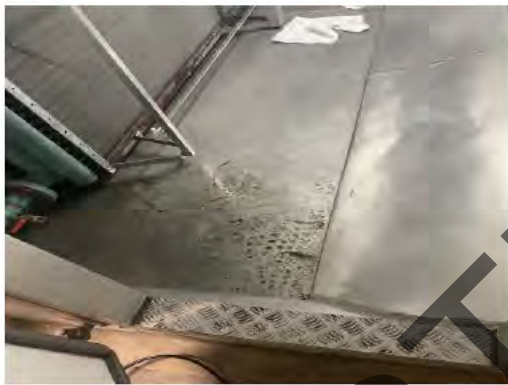
**Image 5 – AHU 1.A Condensate
Tray Before**

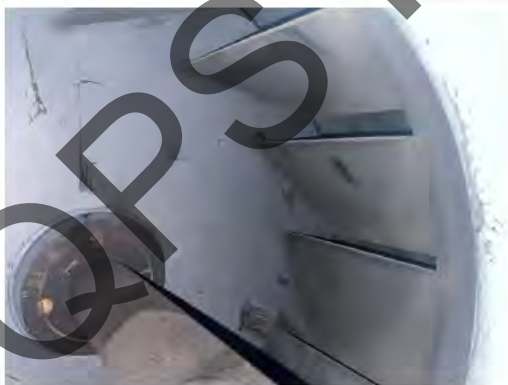
**Image 7 – AHU 1.A Supply Air Fan
Blades Before**

EHS Recommends that the fans for AHU 1.A and AHU 1.B be refurbished due to extensive amounts of rust and corrosion. The rust and corrosion has the potential (if not already) to contaminate the entire system leading to rust/paint particles entering the indoor environment that these units service.

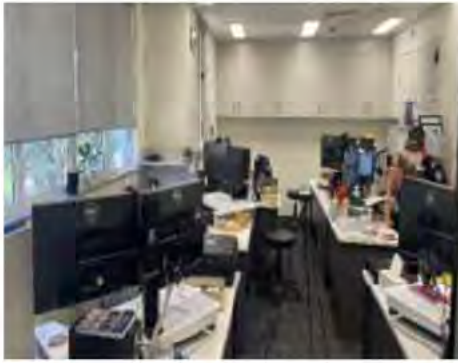
1. **CTPI** Education Training Office (ETO) – General work area was observed to be visibly clean, with plasterboard walls noted with scuff marks and staining.

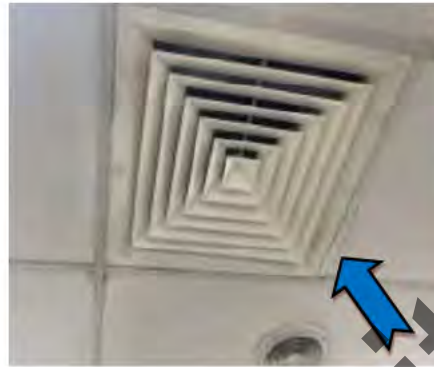
2. **CTPI** Education Training Office (ETO) – Air Supply register noted with dust loading.

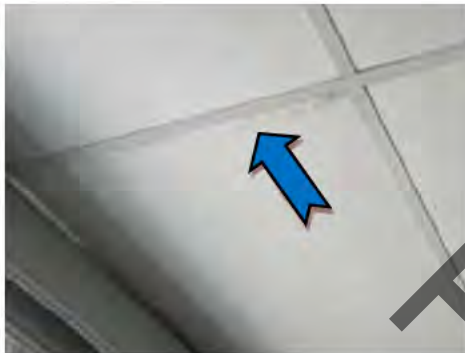
3. **CTPI** Education Training Office (ETO) – Ceiling tile adjacent window noted with dust staining.

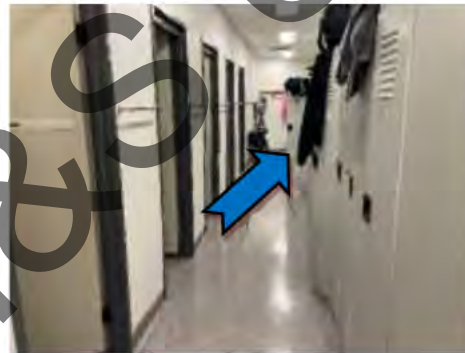
4. **CTPI** Locker Room – General area was observed to be free of grime, however loose contents and dust noted around and on top of personnel lockers.

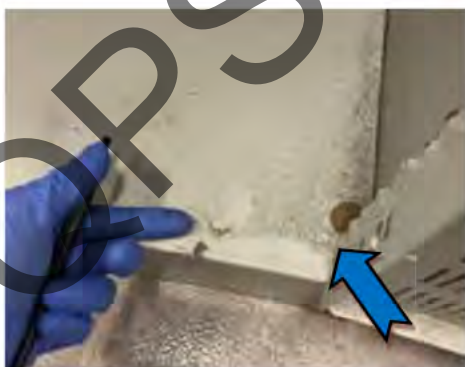
5. **CTPI** Locker Room – Dust loading was observed to shelving within and on top of personnel steel lockers.

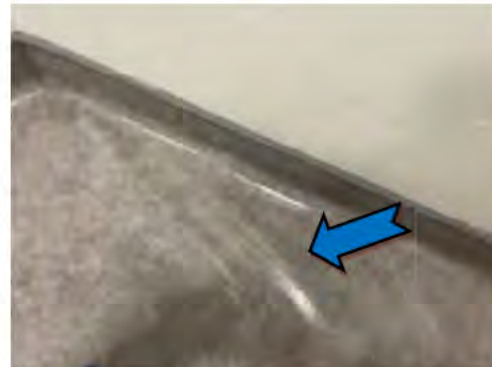
6. **CTPI** Locker Room – Vinyl floor located to the south-east side of the area, was observed to be warped/rippled.

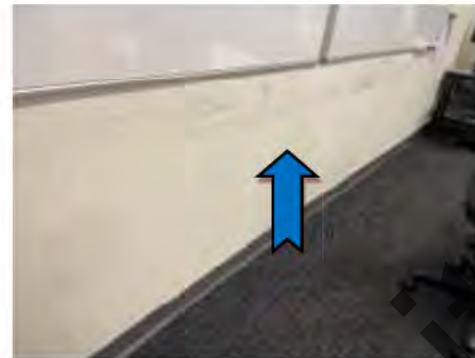
8. CTPI Computer Training Room – Surrounding plasterboard walls within work area noted with scuff marks.

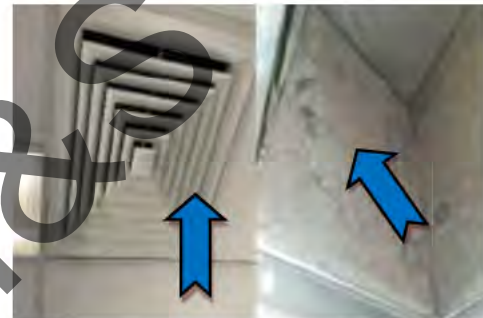
10. CTPI Child Protection Investigation Unit (CPIU) – Air supply register within area observed with moderate levels of dust loading. Also, suspicious mould spotting noted within supply air cushion box (Tape Lift - 111723B-T01-002).

Both Levels, Supply Air Registers	Supply Air Registers (including air supply cushion boxes)	<ul style="list-style-type: none"> At the next scheduled AHU service, conduct sandwich cleaning to registers and cushion boxes where visible dust / suspect mould is observed; Inspect & clean internals of cushion boxes as required. Where active mould growth is identified on porous material such as cushion box SMF insulation, such material should be removed & replaced; As part of this process, conduct additional visual inspections along the internals of supply air ductwork to check for potential heavy dust loading and hidden mould growth between the AHU’s & the on-floor duct outlets.

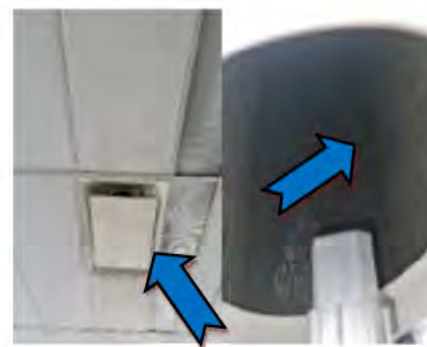
12. CTPI Station OIC – Air supply register and adjacent ceiling tiles within area observed with moderate levels of dust loading. Also, suspicious mould spotting noted within supply air cushion box (Tape Lift - 111723B-T01-005).

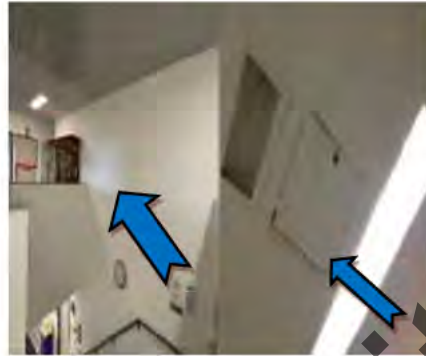
14. Foyer area CTPI [redacted], CTPI [redacted] CTPI [redacted] - Ceiling hatch observed to be swelling, with water staining observed to the plasterboard ceiling.

Key Recommendations		
Location	Feature	Recommendation
Level 1 central internal	Ceiling Hatch, ceilings generally	<ul style="list-style-type: none"> Water damaged plasterboard and MDF materials (e.g. ceiling hatch near top of internal stairs, other affected ceiling tiles where encountered) should be removed and replaced.
Both Levels	Throughout Content items & points of water ingress	<ul style="list-style-type: none"> Clean or remove any mould affected contents encountered (e.g. dispose of mould affected fabric bags); Verify all and any roof leaks (or other leaks including from plumbing) are rectified as soon as practicable to minimise the risk of future mould amplification; Conduct frequent inspections of all occupied spaces for new water stains and suspect surface mould growth, and remediate as required in accordance with Section 12 of this report.

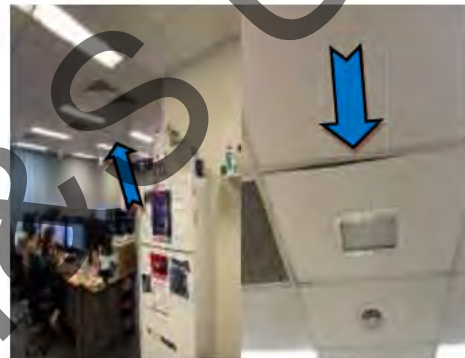
16. CTPI [redacted] District Intel - General area was observed to be visibly clean, with a plaster ceiling tile noted to be jutting out in the main office area.

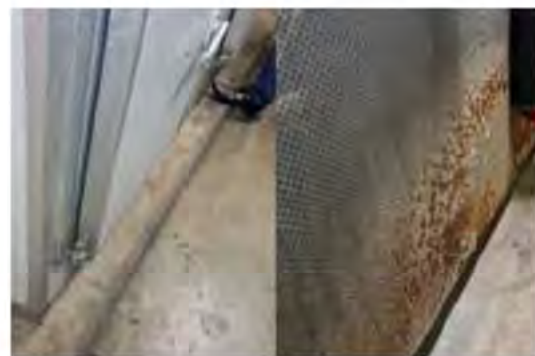
18. CTPI [redacted] Plant Room - The general area was observed to be affected by low levels of grime and dust, with suspicious mould spotting on pipework, joins, and connections. Further there was visible corrosion to metal walls, doors, latches, ductworks, and AHU housing.

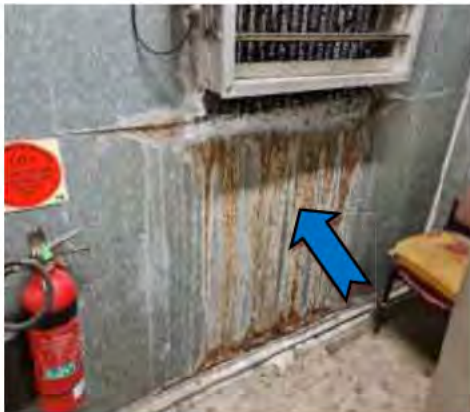
19. CTPI AHU Plant Room (East Side) – Visible corrosion was observed on the metal wall under the fresh air intake dampers.

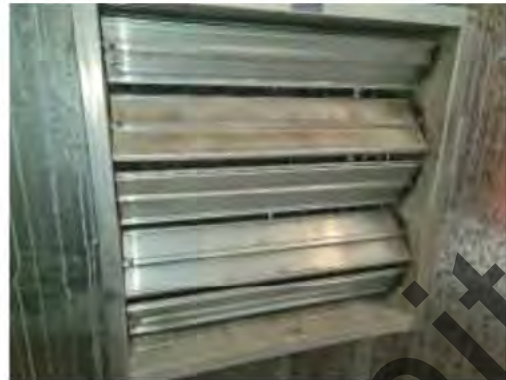
20. CTPI Plant Room (West Side) – The fresh air intake grill was noted to be mostly blocked by detritus (leaf matter, feathers, etc)

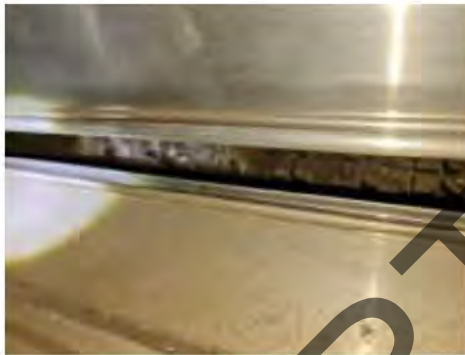
21. CTPI Plant Room (West Side) – The fresh air intake grill was noted to be mostly blocked by detritus (leaf matter, feathers, etc)

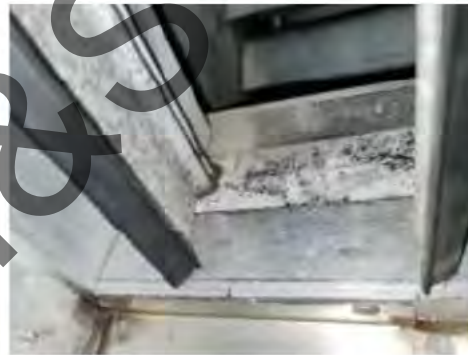
22. CTPI Plant Room (West Side) – Suspect mould on supply air dampers. Surface sample 111723B-T01-001 was collected here.

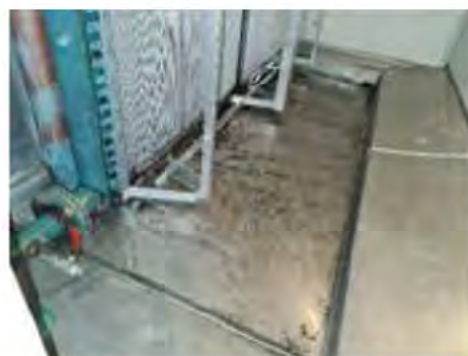
24. CTPI AC Plant Room (East Side) – Representative Grime and Corrosion in Supply Air Chamber & condensate tray

Key Recommendations		
Location	Feature	Recommendation
Both Levels, AHU’s	Throughout surfaces, within the chambers:	<ul style="list-style-type: none"> At the next scheduled AHU service, perform a full ‘sandwich’ clean to all internal surfaces including suspected mould affected surfaces, to remove all visible sources of grime and suspect mould. This should include all of the less accessible areas as far as practicable (e.g. around dampers, behind & under supply fans etc.); Visually assess these areas / surfaces on a frequent basis and during scheduled maintenance activities, and conduct further cleaning as required where grime / suspect mould presents.
Both levels, AHU plant rooms	All surfaces of the general plant room areas (i.e. outside of the AHU’s)	<ul style="list-style-type: none"> Perform a thorough ‘sandwich’ clean of all surfaces within the plant rooms to remove visible grime / suspect mould (incl panels, high level areas, grills/dampers, floor etc.); Assess corroded components and upgrade as practicable (such corroded surfaces can harbour grime & microbial activity & be harder to clean).

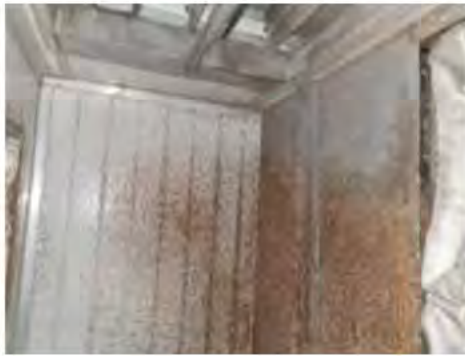
25. CTPI Plant Room – Representative corrosion in Mixing Chamber (AHU 1.A)

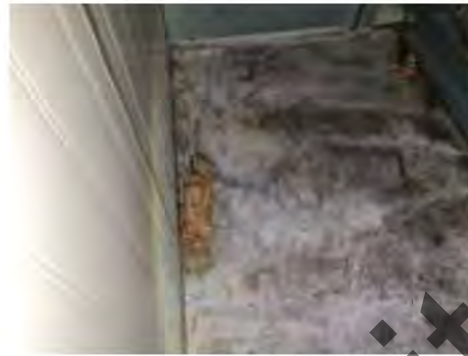
26. CTPI Plant Room – Rust and Grime in Fan Chamber (AHU 1.B)

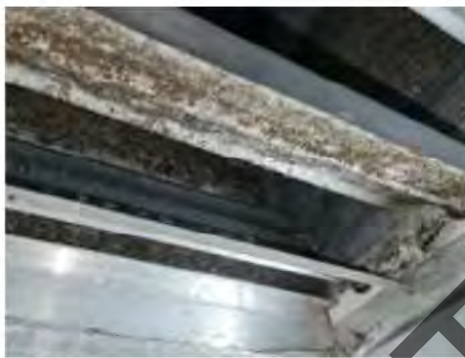
27. CTPI Plant Room – Grime and suspect mould on supply air dampers (AHU 1.B)

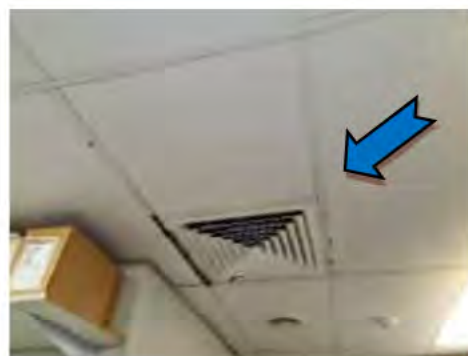
30. CTPI Scene of Crime (SOC) – Air Supply register observed to have dust loading with adjacent plaster ceiling tile noted to be peeling.
