MOULD ANALYTICAL REPORT

Property: WO17802457
Logan Central Police Headquarters

Mould Investigation

Logan Central Police Station

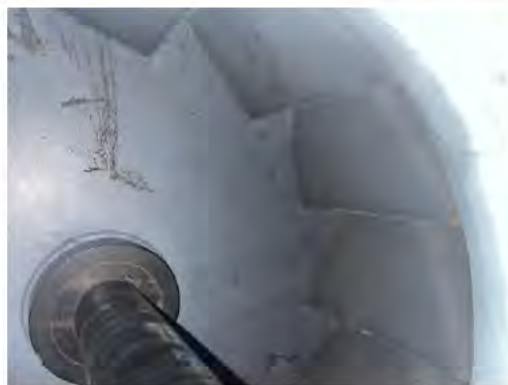
Image 9 – AHU 1.A Supply Air Fan Blades Before

EHS Recommends that the fans for AHU 1.A and AHU 1.B be refurbished due to extensive amounts of rust and corrosion. The rust and corrosion has the potential (if not already) to contaminate the entire system leading to rust/paint particles entering the indoor environment that these units service.

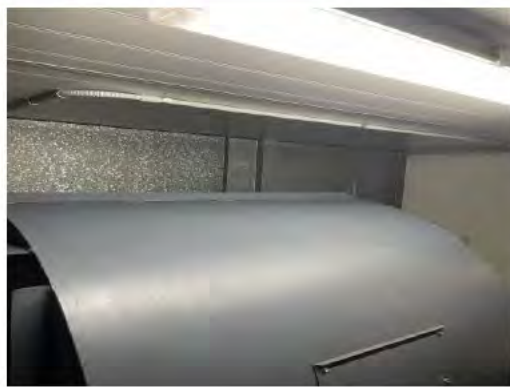
Image 15 – AHU 1.A Return Air Plenum Before

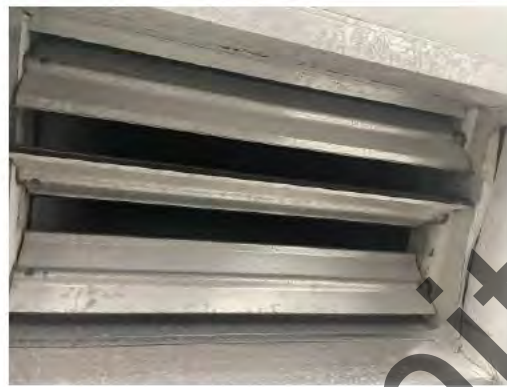
Image 17 – AHU 1.A Return Air Plenum Before

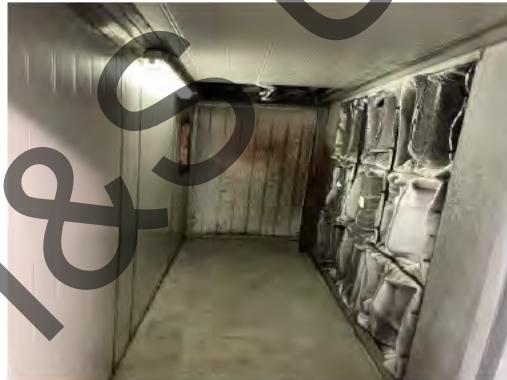
Image 19 – AHU 1.A Return Air Plenum Filters Before

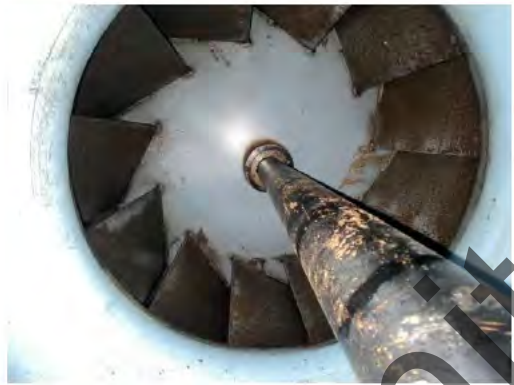
Image 29 – AHU 1.B Supply Air Fan Blades Before

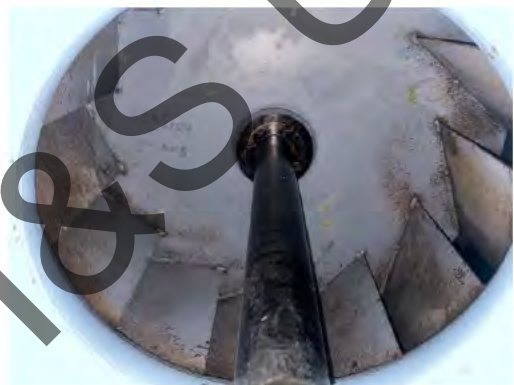
Image 31 – AHU 1.B Supply Air Barrel Fan Before

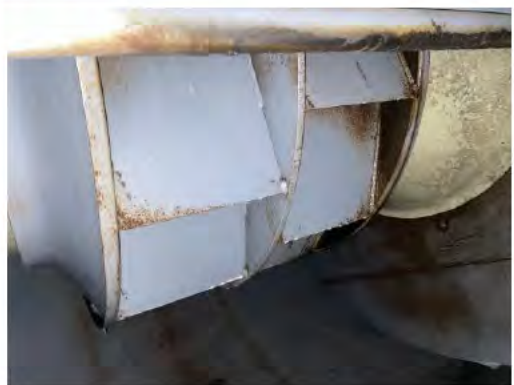
Image 33 – AHU 1.B Supply Air Fan/Plenum Before

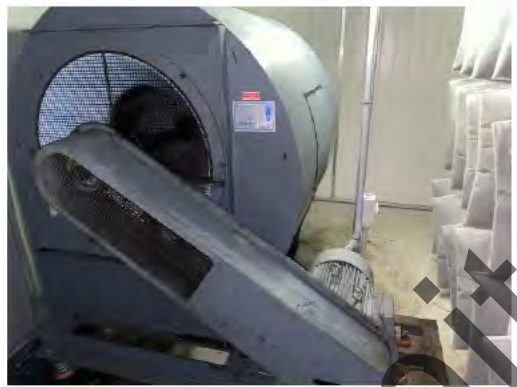
Image 35 – AHU 1.B Supply Air Fan/Plenum Before

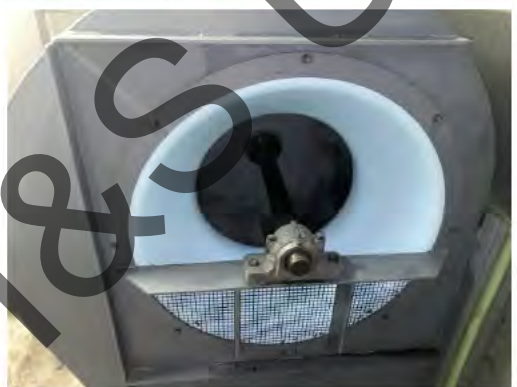
Image 37 – AHU 1.B Supply Air Plenum Before

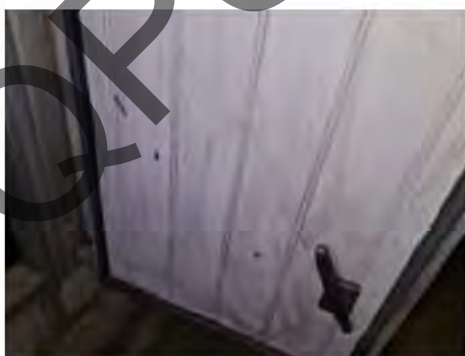
22. CTPI Plant Room (West Side) – Suspect mould on supply air dampers. Surface sample 111723B-T01-001 was collected here.

Key Recommendations		
Location	Feature	Recommendation
Both Levels, AHU’s	Throughout surfaces, within the chambers:	<ul style="list-style-type: none"> At the next scheduled AHU service, perform a full ‘sandwich’ clean to all internal surfaces including suspected mould affected surfaces, to remove all visible sources of grime and suspect mould. This should include all of the less accessible areas as far as practicable (e.g. around dampers, behind & under supply fans etc.); Visually assess these areas / surfaces on a frequent basis and during scheduled maintenance activities, and conduct further cleaning as required where grime / suspect mould presents.
Both levels, AHU plant rooms	All surfaces of the general plant room areas (i.e. outside of the AHU’s)	<ul style="list-style-type: none"> Perform a thorough ‘sandwich’ clean of all surfaces within the plant rooms to remove visible grime / suspect mould (incl panels, high level areas, grills/dampers, floor etc.); Assess corroded components and upgrade as practicable (such corroded surfaces can harbour grime & microbial activity & be harder to clean).

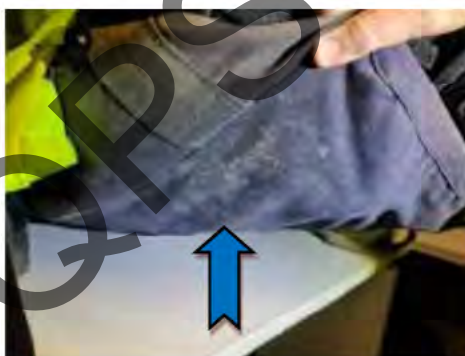
28. CTPI Plant Room – Supply Air Duct via inspection hatch downstream of Supply Air Chambers (AHU 1.A and AHU 1.B)
