MOULD ANALYTICAL REPORT

Property: WO17802457
Logan Central Police Headquarters

Mould Investigation

Logan Central Police Station

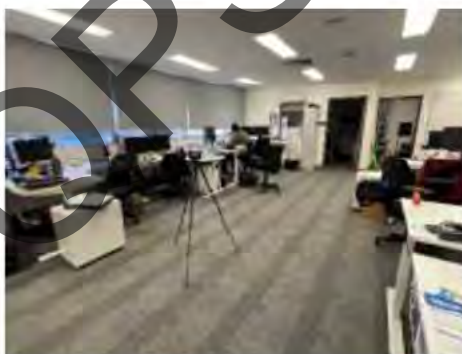
10. CTPI Child Protection Investigation Unit (CPIU) – Air supply register within area observed with moderate levels of dust loading. Also, suspicious mould spotting noted within supply air cushion box (Tape Lift - 111723B-T01-002).

Both Levels, Supply Air Registers	Supply Air Registers (including air supply cushion boxes)	<ul style="list-style-type: none"> At the next scheduled AHU service, conduct sandwich cleaning to registers and cushion boxes where visible dust / suspect mould is observed; Inspect & clean internals of cushion boxes as required. Where active mould growth is identified on porous material such as cushion box SMF insulation, such material should be removed & replaced; As part of this process, conduct additional visual inspections along the internals of supply air ductwork to check for potential heavy dust loading and hidden mould growth between the AHU’s & the on-floor duct outlets.
